HAZARD ALERT

LOG CRASHES THROUGH REAR WINDOW OF FORWARDER

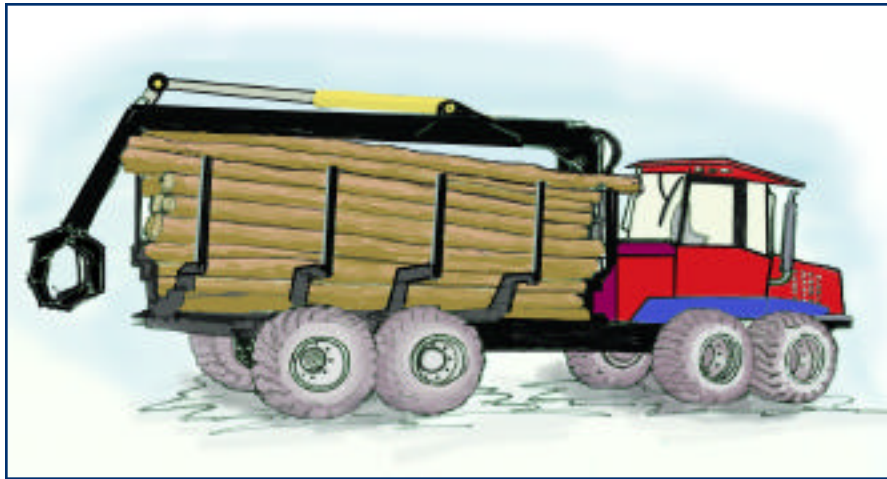
The operator of an eight-wheeled forwarder narrowly escaped injury when a log slid forward over the bunk of the load he was

transporting and crashed through the rear window of the cab. The operator was traveling to roadside with a full load of logs when the logs shot forward as the equipment drove through the roadside ditch. "I thought the glass was

The WHSCC investigation revealed that the rear

window was the original one supplied with the machine. It was made of 9mm thick Marguard. This type of Lexan glazing is only designed to take the shock of protruding branches and not the full force of a log.

- Don't overload the machine. Logs should be contained inside the bunk area.

- Don't rely solely on glazing as a safeguard against injury. Although glazing materials have improved over the years, their strength can decrease over time with the effects of UV rays and contact with hydraulic oils or petroleum-based products.
- Replace Lexan that:
 - becomes hazy or yellow,
 - has a scratch on either side that can be felt with a fingernail, *or*
 - has small cracks coming from the edges or mounting holes.
- For unguarded Lexan material, install appropriate metal guarding if there is a likelihood that the window will be struck with severe impact.
